FINAL INCIDENT REPORT

Landing with Weight & Balance CG Out of Limits
EZ Air, Air Operator Certificate No. 17
SAAB 340B
N417XJ, MSN 417
Flight 7Z-0571 from Curaçao (TNCC) to Bonaire (TNCB)

18 December 2024

Final Incident Report
CURCW/24/1134

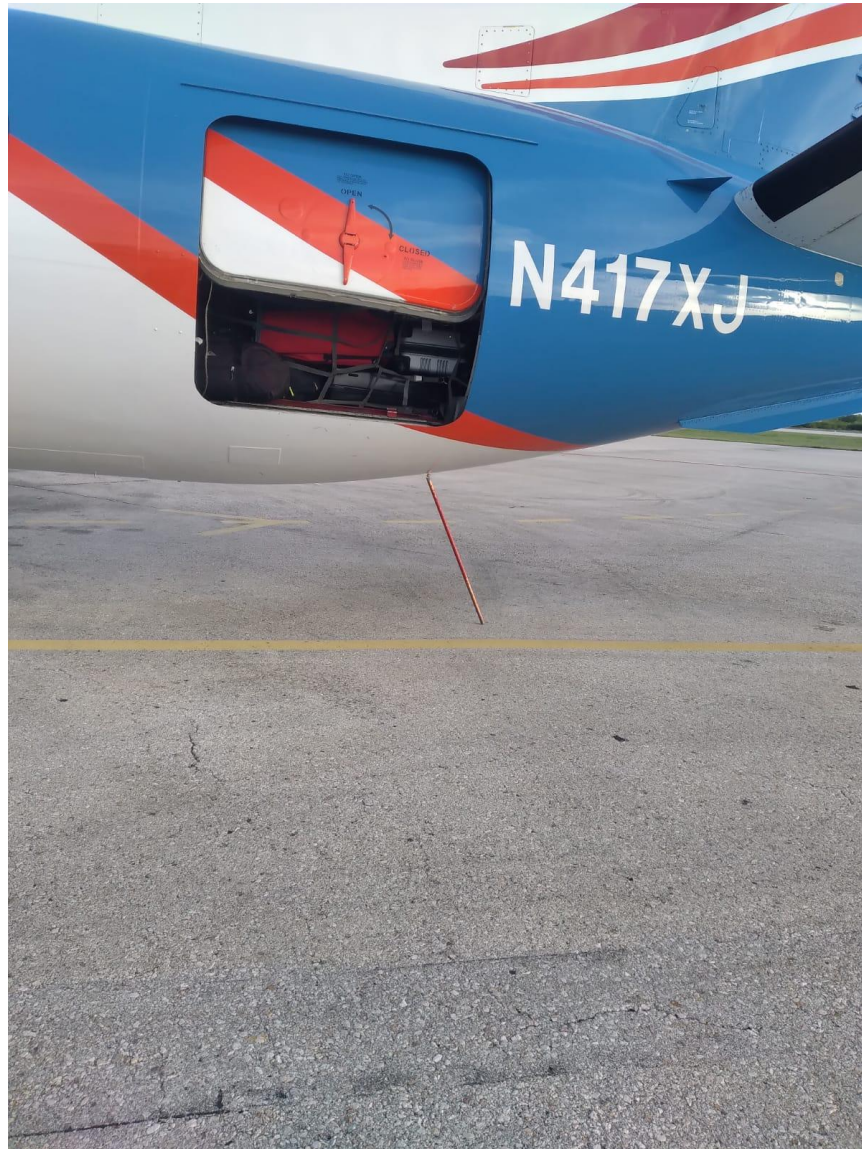
PIC Taken by Ground Crew **WITH PAX ONBOARD**

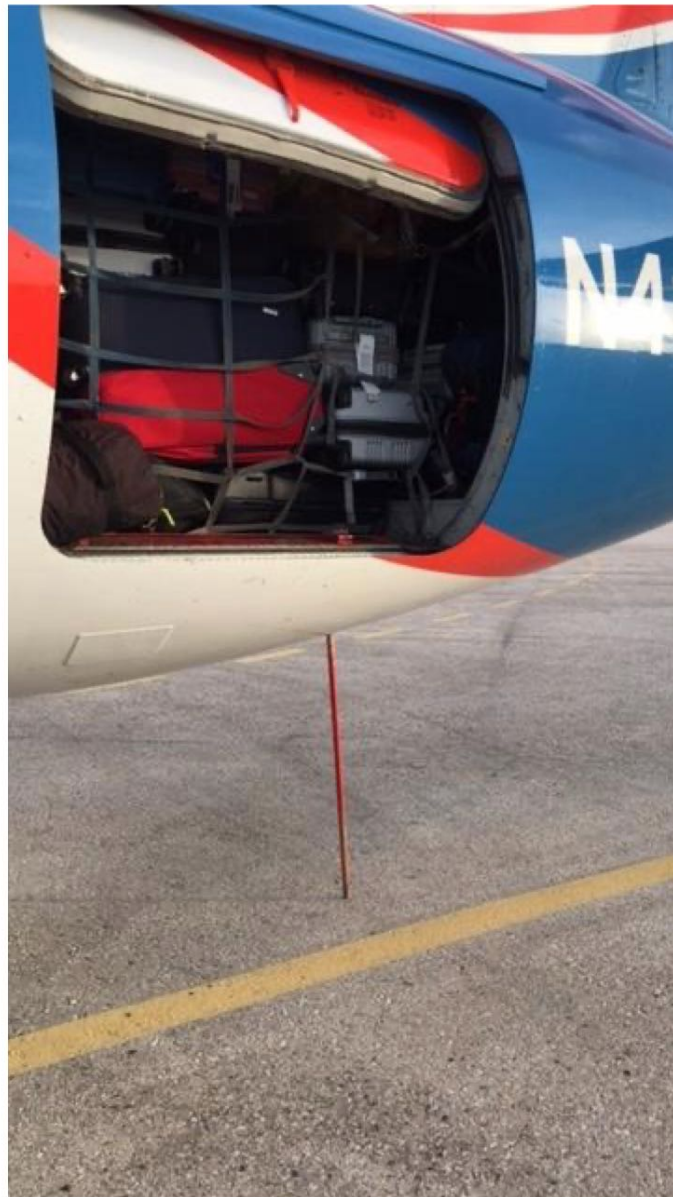
Aircraft **without passengers** with Baggage as loaded in CUR. Notice the tail strut is still at an angle.

According to SAAB AB, in this picture, the center of gravity is at about 32% MAC (MID/AFT, about 3/4 of the envelope).

Ref. text on page 12, the support should still have to stand with some inclination.

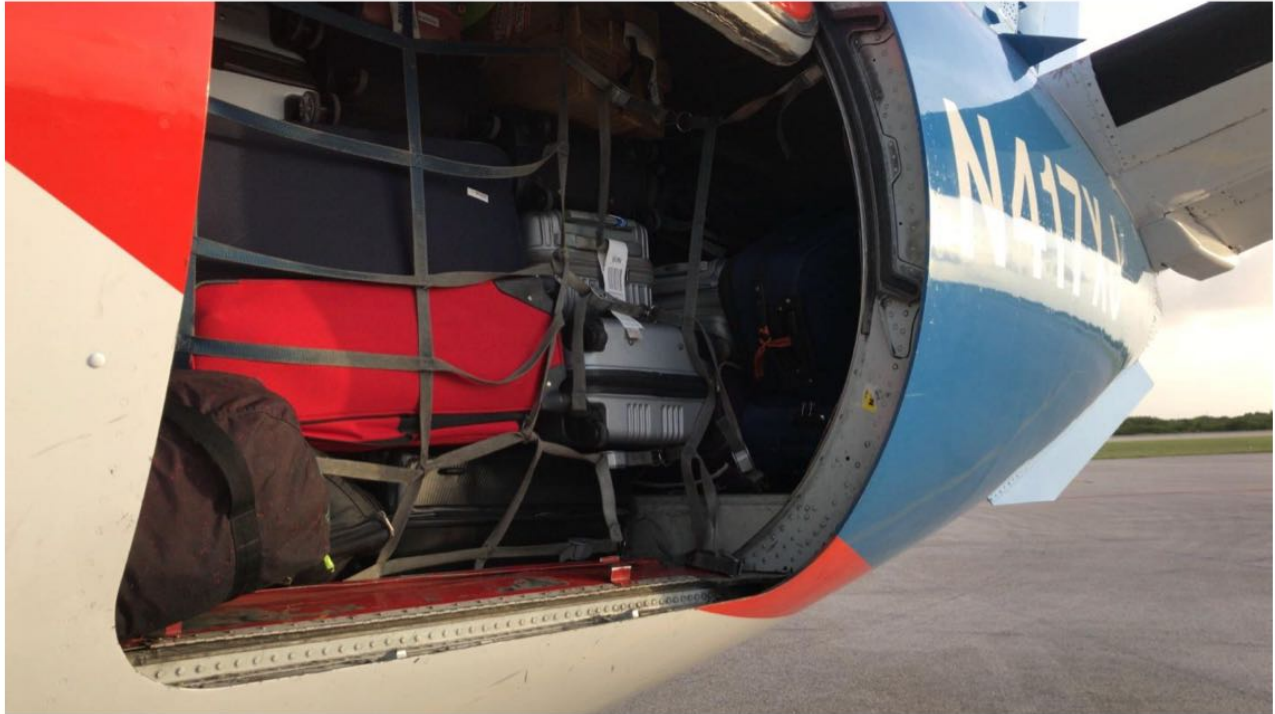
Close up PIC of the Cargo Compartment before Offloading

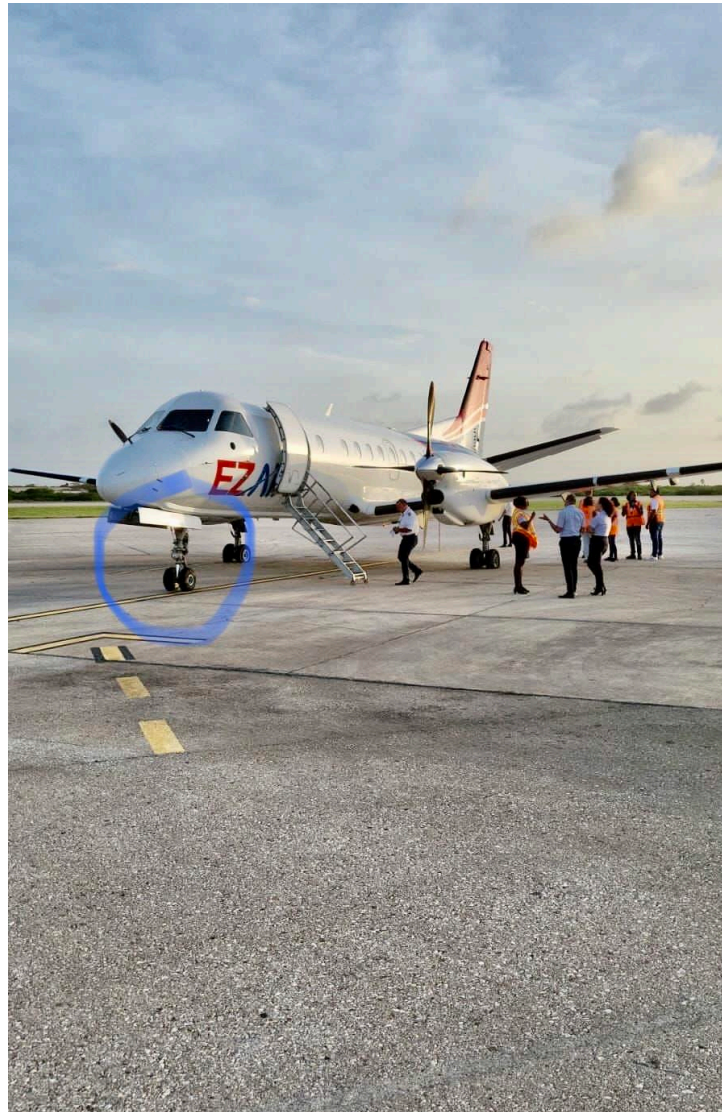
Notice the extended nosewheel strut with aircraft without passengers but still loaded with baggage and cargo.

As per SAAB 340 design, the nose gear will reach max extended position with approximately 520 lbs. cargo (ref ACAP 05-00 sect. 9).

Approximately 1770 lbs. of baggage/cargo is loaded in the aircraft in this picture.

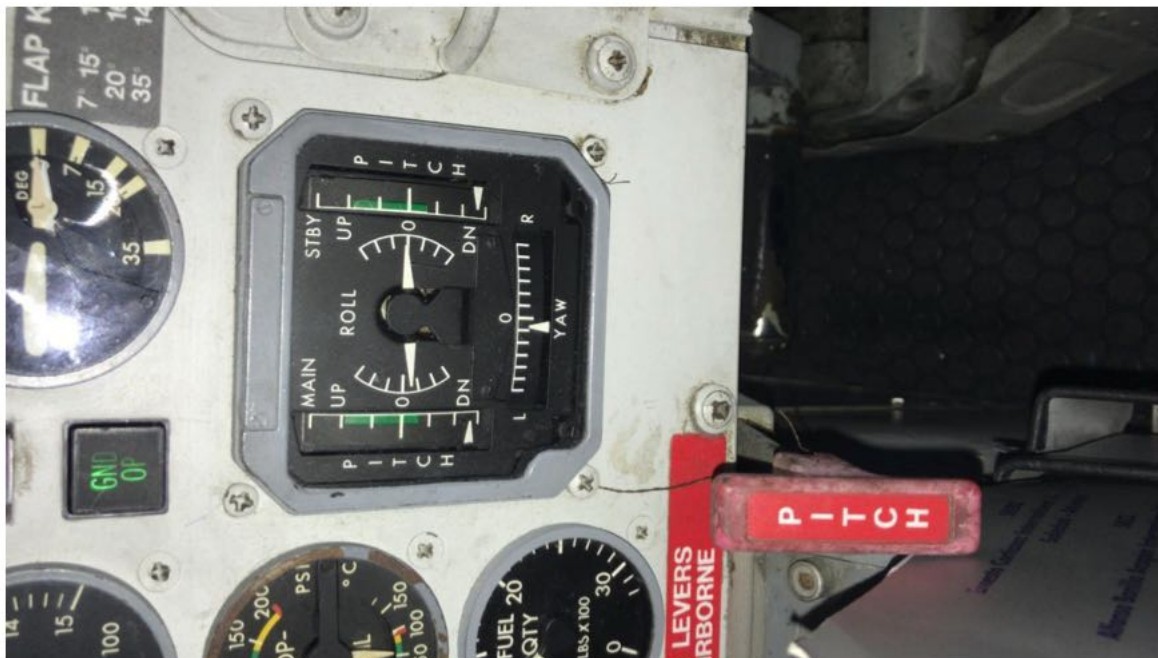
PIC shows FULL pitch DOWN after parking. During Approach it was over 1 ½ Down and during TAXI requested the FO to TRIM further DOWN in the hope that all bits will help keep the nose wheel firm on Ground

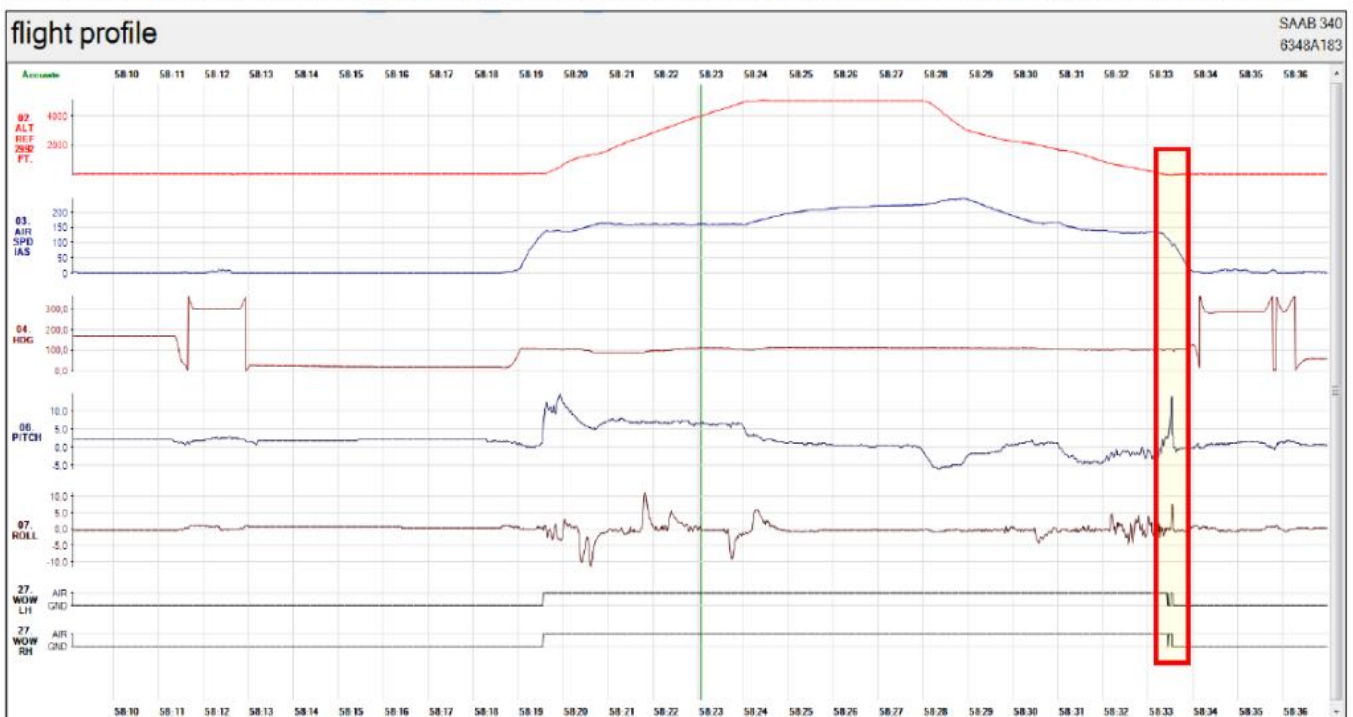
N417XJ EZAIR DFDR EVENT REPORT GRAPHS

Overall Flight profile for the last flight, complete data download from aircraft power up to power down. Notice highlighted area during touch down for abnormal High pitch and High Roll, also WOW bouncing.

The FDR recording shows a pitch rise tendency when pitch trim was changed from -1.7 to -1.3 (nose up) at RA Altitude of 42', and a power reduction at RA Altitude of 25' followed by a pitch increase.

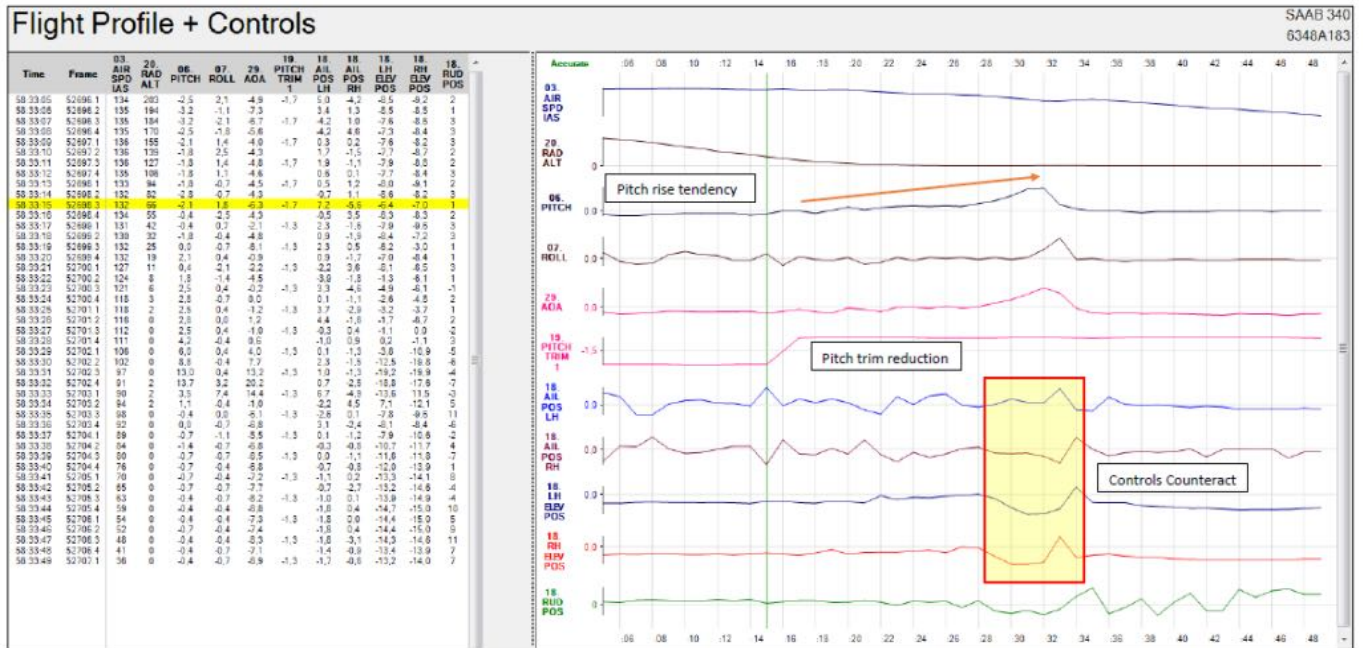
N417XJ EZAIR DFDR EVENT REPORT GRAPHS

Zoomed detail for touch down, including flight controls, at recording time 58:33:17 there is a Pitch trim reduction from -1.7 to -1.3, can be correlated to Pitch Rise tendency. Elevator and ailerons operated to counteract high pitch and high roll as highlighted.

Second pitch reduction at RA Altitude of 8' indicates a further increase in Pitch, thereafter at RA Altitude of 0' the FDR recorded an increase of pitch up to a value of 13.7°, in combination with a high roll. During touch-down a high pitch and high roll with bouncing (WOW) was recorded.

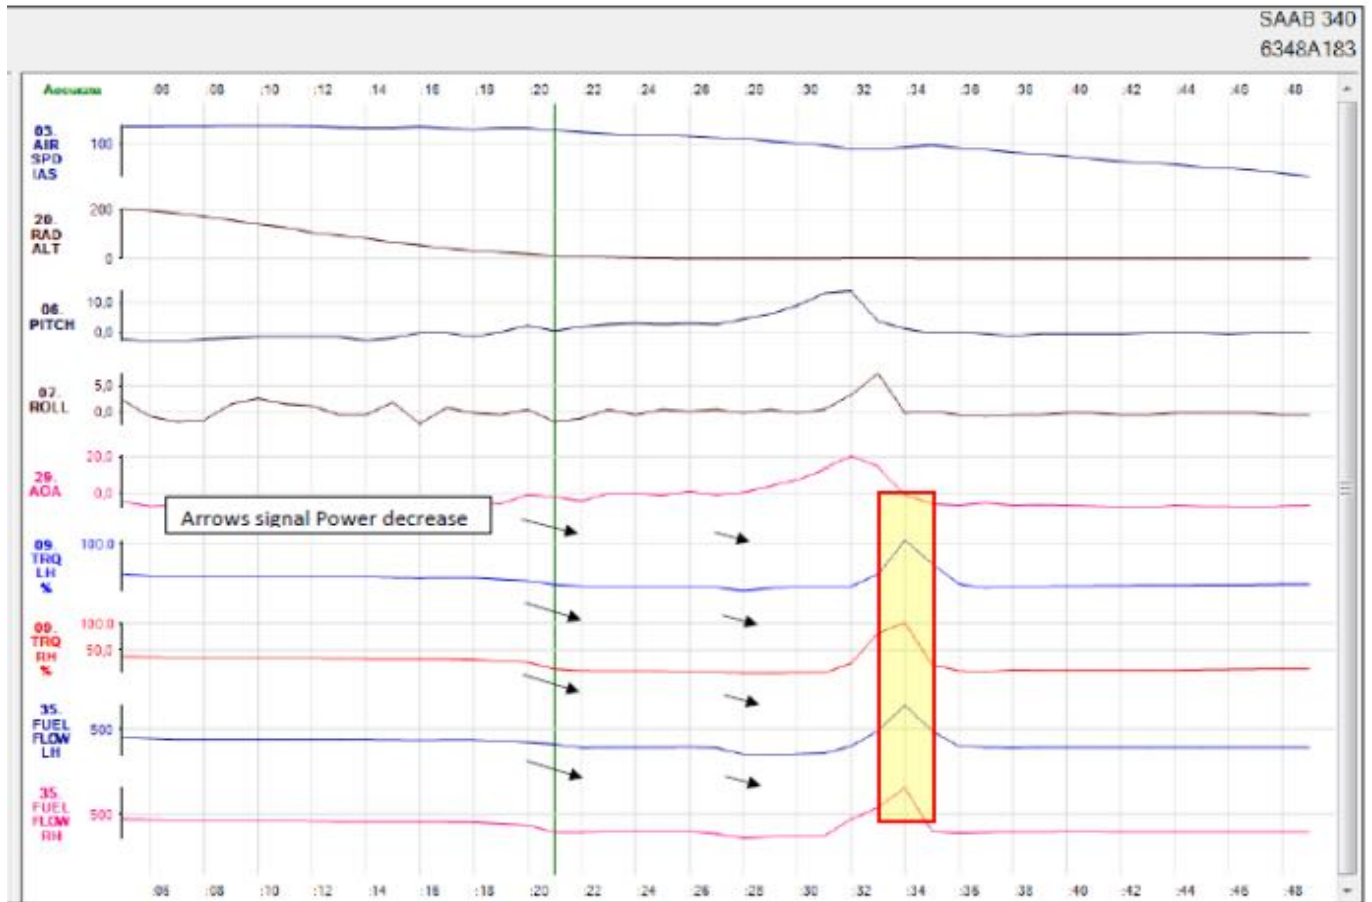
After high pitch rise and high roll rise, maximum power was applied, and pitch was lowered.

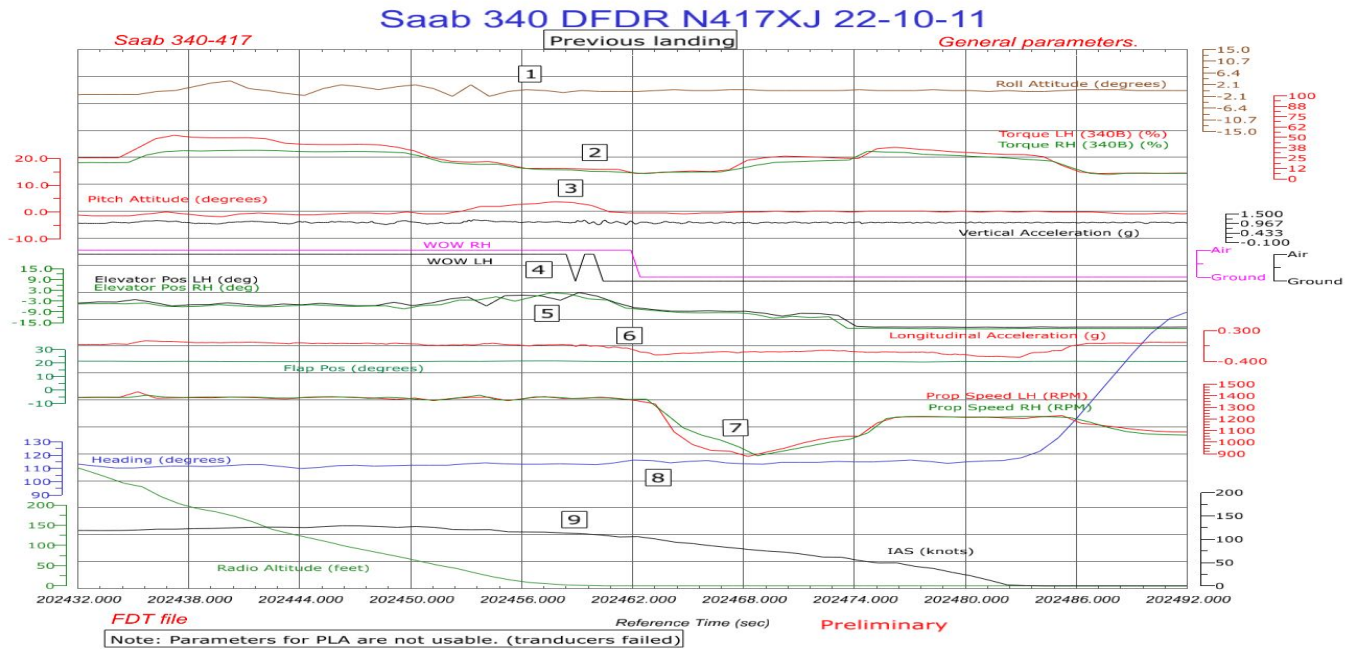
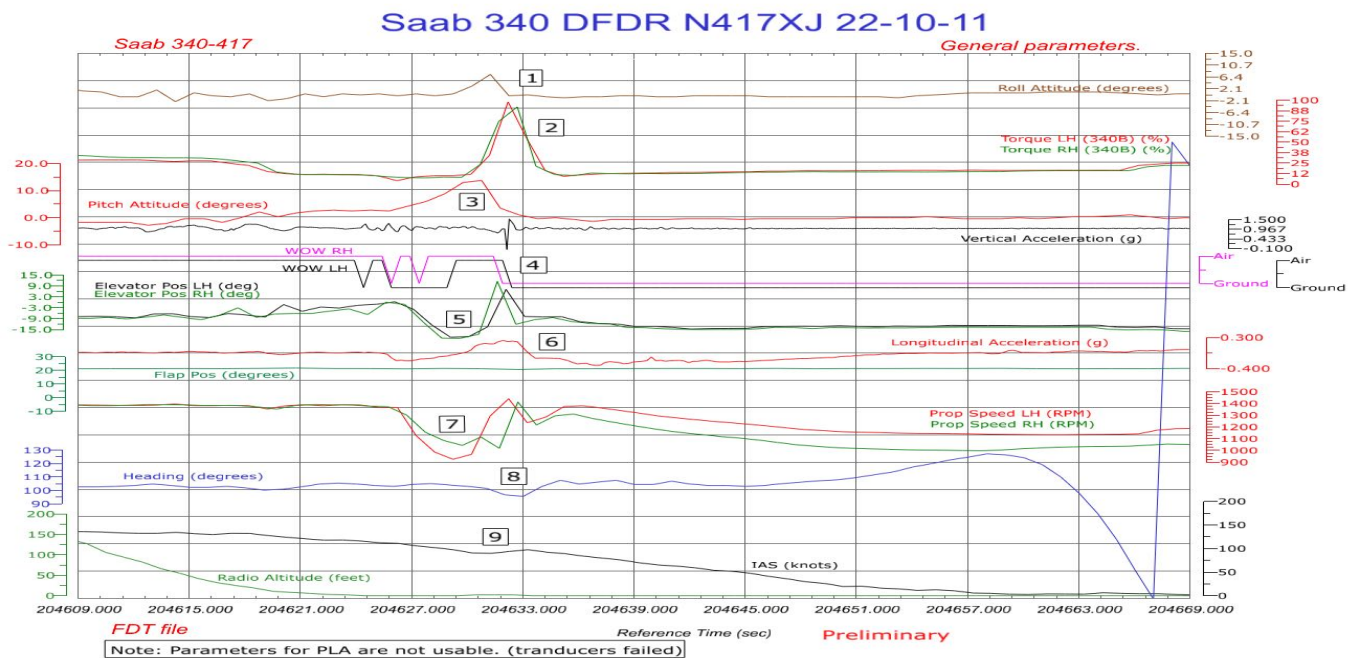
Following is a summary of observations from FDR-data by comparing the FDR data from the **Previous Landing** with the **Incident Landing** from the above charts. The following observations can be made.

Incident Landing: The Roll Attitude indicates a RH Roll up to 7 degrees during the bounced touch-down.

Incident Landing: The L+R Engine Torque is abruptly increased and then reduced just before both Weight on Wheel switches indicates "on ground".

Incident Landing: After touch down, the Pitch Attitude is about 4 degrees when the Prop RPM starts to decrease to around 940rpm on the LH Engine and 1050RPM on the RH engine.

Incident Landing: The Weight on Wheel switches indicates a bounced landing with transitions from Air to Ground, back to Air and then back to Ground for a duration of about eight seconds.

Incident Landing: The recorded Elevator Positions indicates a sharp Elevator down followed by a sharp Elevator up command ending with Elevator down.

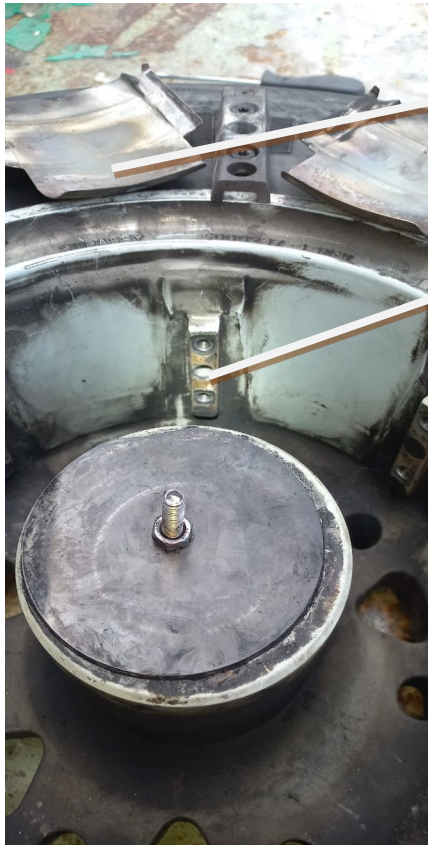
- 2.4 Taxiing to the parking position was with power above ground idle to avoid pitch up during taxi. This resulted in the extensive use of brakes causing the brakes to develop heat and causing the thermal fuses of the main wheels to activate. This in turn releases the tire pressure slowly, preventing explosion of the tires and damage to the aircraft.

Melted Thermal fuse shown here with "KEY"

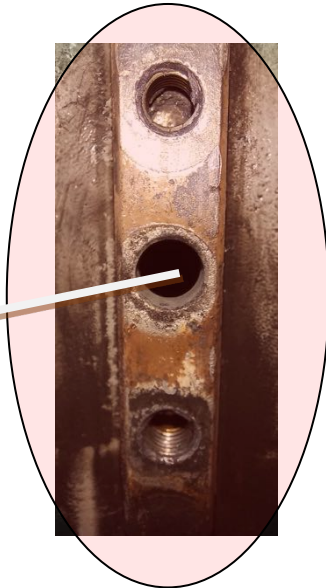
Melted Thermal fuse shown here with "KEY" removed.

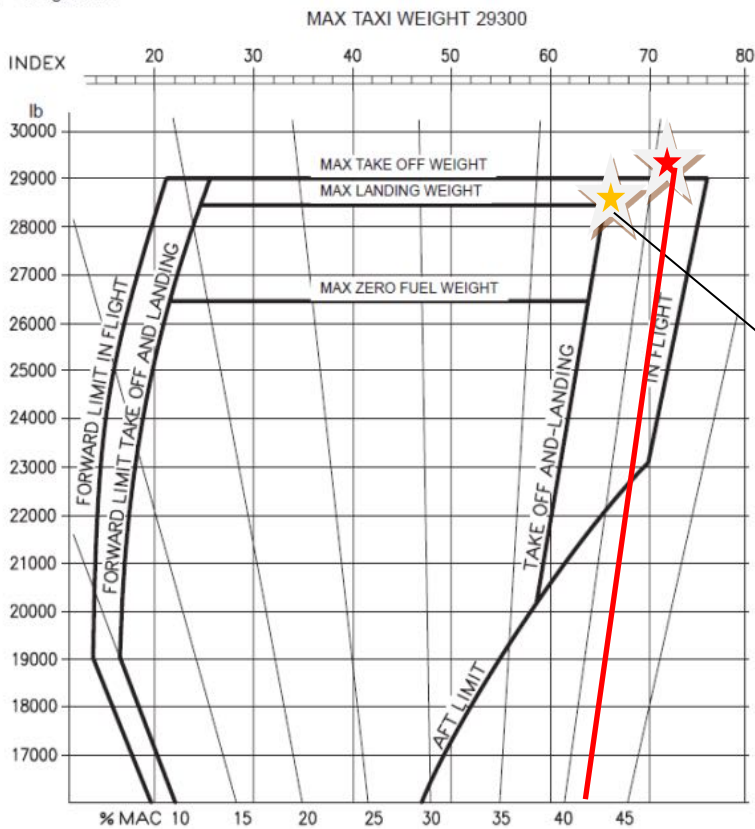
Estimate CG without extra Baggage/Cargo & Pax Hand luggage moved to C1/C2
