FINAL INCIDENT REPORT

Landing with Weight & Balance CG Out of Limits
EZ Air, Air Operator Certificate No. 17
SAAB 340B
N417XJ, MSN 417
Flight 7Z-0571 from Curaçao (TNCC) to Bonaire (TNCB)

18 December 2024

Final Incident Report
CURCW/24/1134

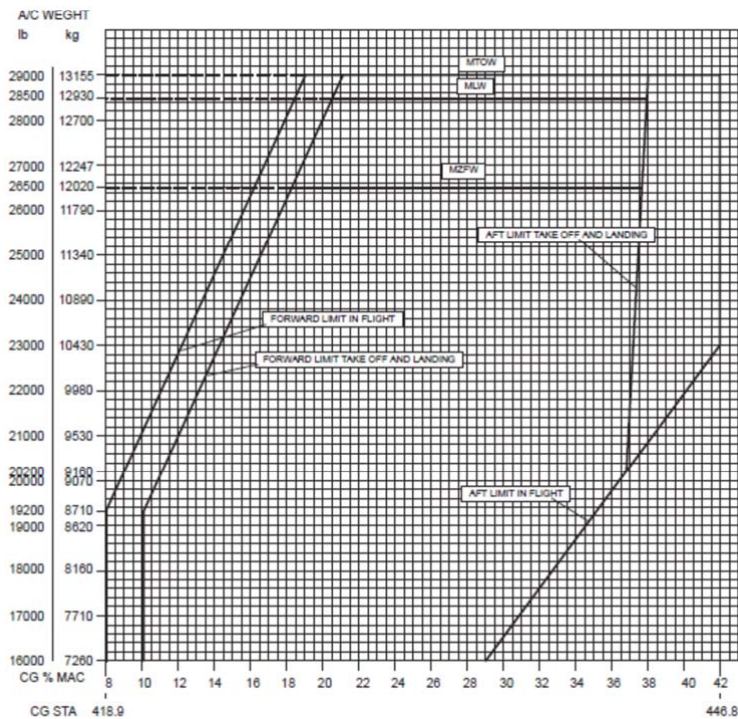
A11226 CENTER OF GRAVITY LIMITS GRAPH, 340B, post-MOD NO 2438 (SB SAAB 340-51-010) FIG. 7

Refer to figure 1 & 2 for an exploded view of the LS CG LIMITS TABLE & GRAPH.

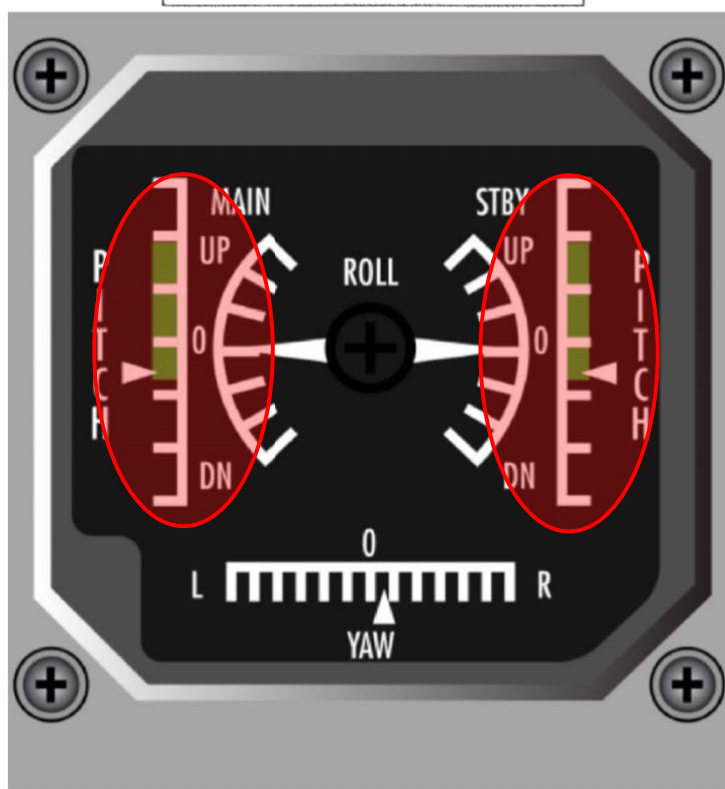
Figure 4

Be aware of the GREEN BAND (refer to Figure 4) on the pitch trim indicator, although this Green band indicates take-off range, it may give a good indication during final approach to landing on what to expect.
